Roussas-Claves wind farm optimisation through rotor balancing

PO.163

Bruno Pinto¹, Nicolas Ribaud²
1 – Sereema, Montpellier, France
2- RES France, Avignon, France

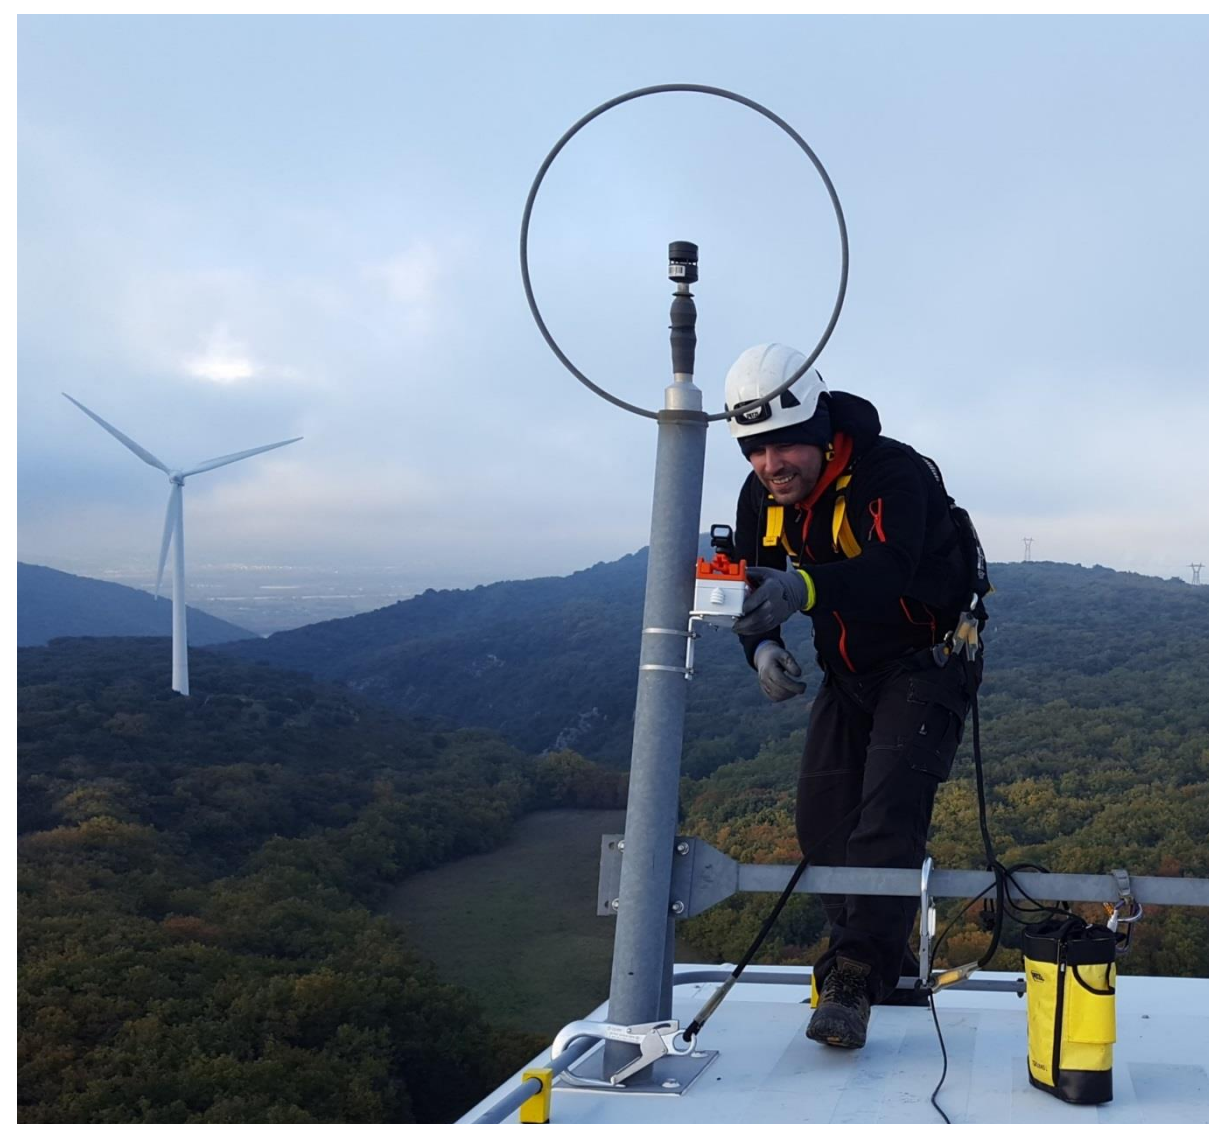
Figure 1: Windfit box set on the met mast of a Vestas V66 of the Roussas-Claves wind farm by RES

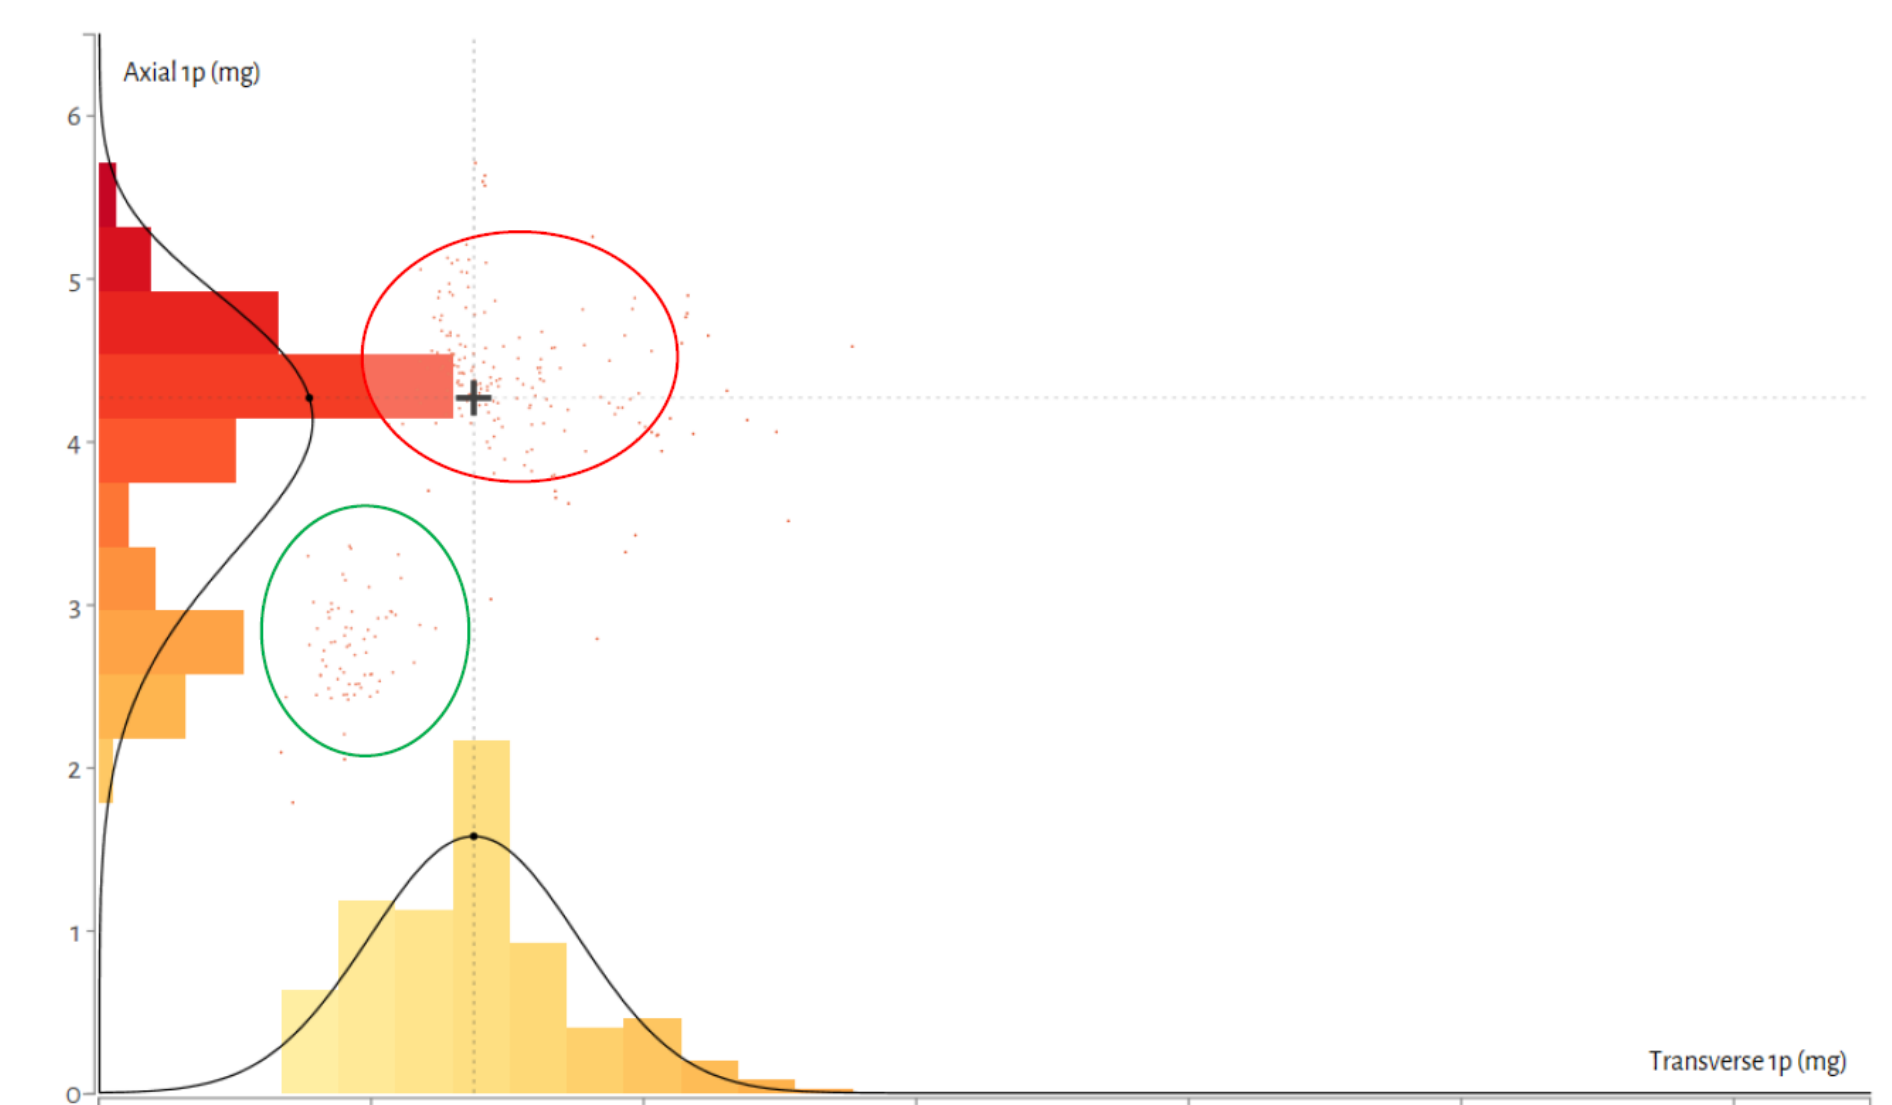
The rotor balance analysis identified 2 out of the 6 wind turbines on the farm presenting an aerodynamic imbalance. These diagnoses were confirmed on-site by RES by who verified the TC Marks of the individual blades on both wind turbines: a shift on the pitch of one blade of 1.6 degrees and 1.7 degrees was identified, respectively.

Figure 2: Comparison of the acceleration levels at the 1p frequency in both axial and transverse axis before and after pitch shift correction. The individual values before and after correction are circled by the red and green circle respectively

The correction was done by screwing/unscrewing the rod of the hydraulic cylinder of the pitch of the affected blade. Due to mechanical limits on the stroke of the hydraulic cylinder, only a partial correction (final shift of 0.7 degrees) was done on the first wind turbine and the complete correction is scheduled for the second wind turbine. The results after correction show a significant reduction in the 1p acceleration levels as shown in figure 2: the accelerations caused by the rotor imbalance were reduced by 50% with the partial pitch shift correction. In addition, an improvement of the power curve for the first wind turbine was attained, the gain in production is estimated at 2% AEP. To illustrate this gain, the average normalised power curves before and after correction are presented in the figure 3.

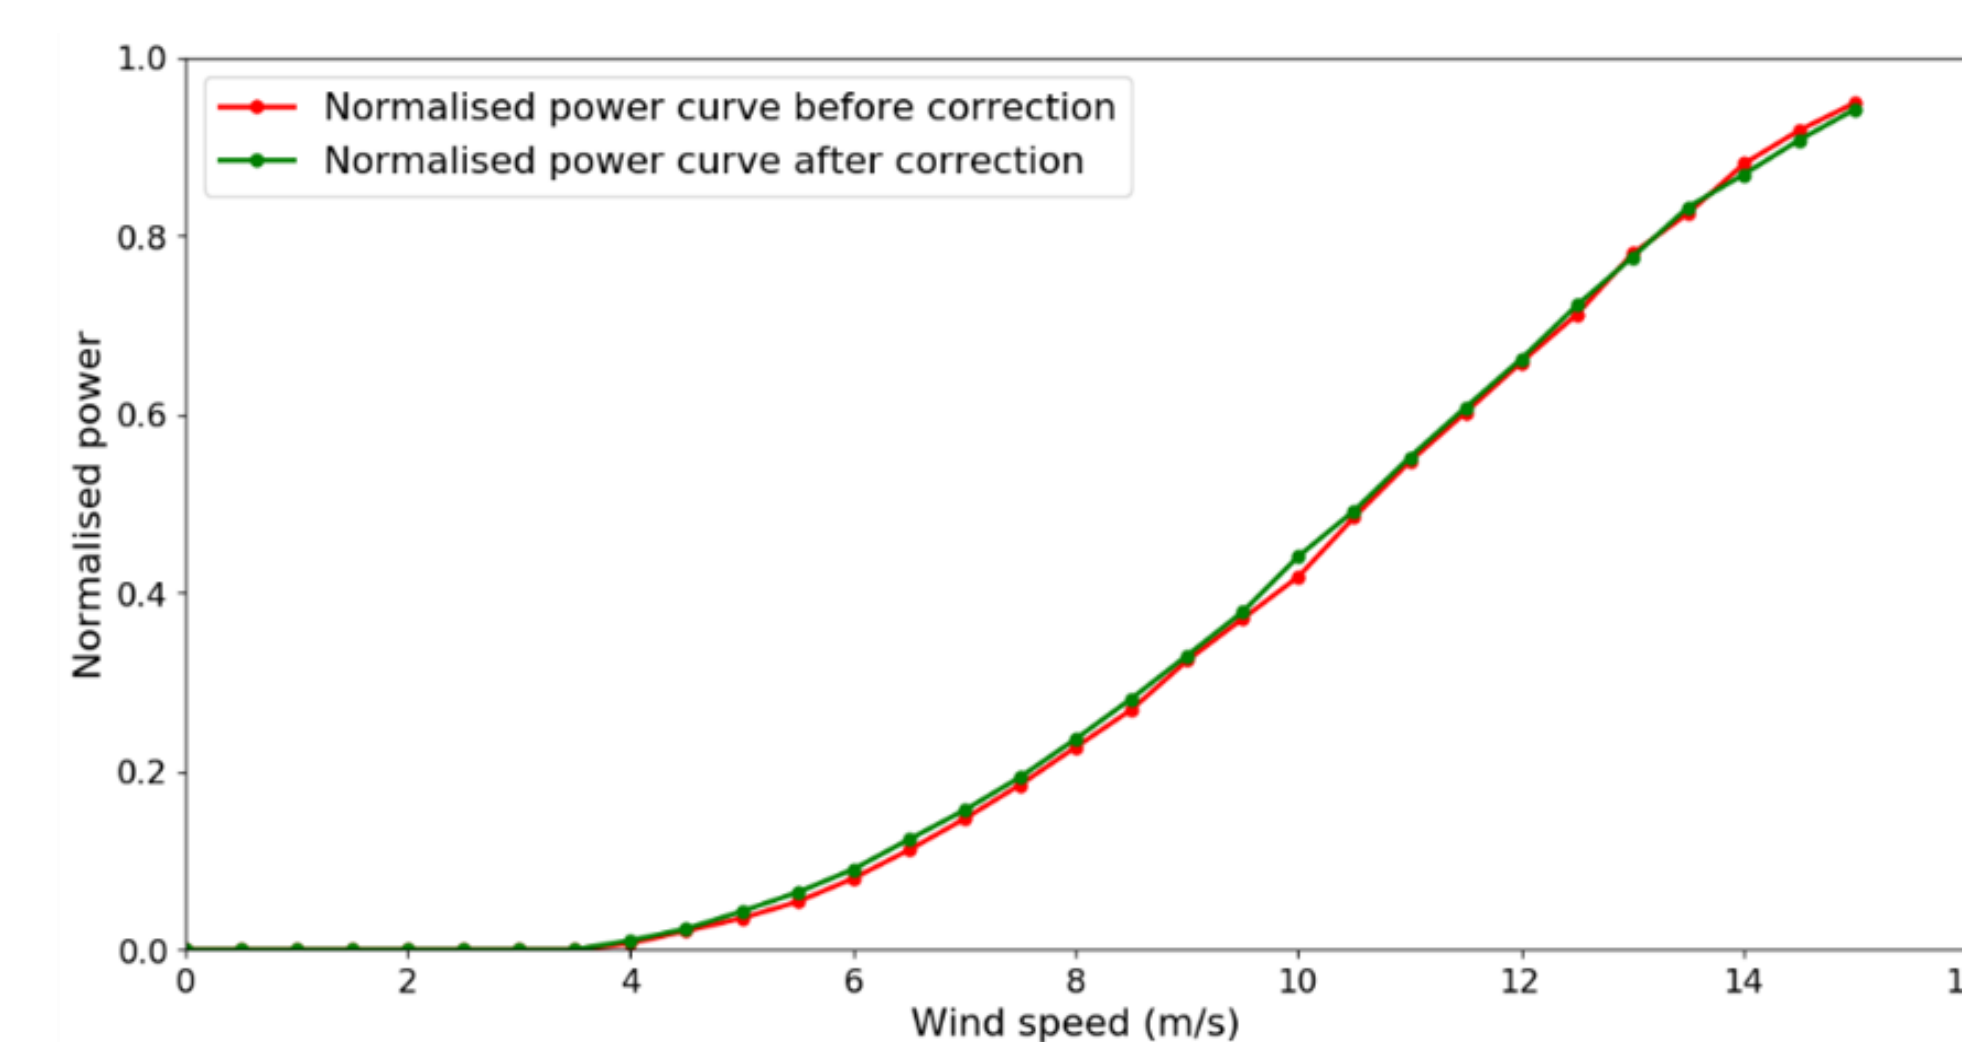
Figure 3: Average normalised power curves before and after the partial pitch offset correction. The improvement after correction is estimated at 2% AEP
